## COLORADO CULTURAL RESOURCE SURVEY

### Architectural Inventory Form

1. Resource Number: 5DA2672
2. Temporary Resource Number: 759
3. County: Douglas
4. City: Castle Rock
5. Historic Name: Senter Residence
6. Current Building Name: Reese Residence
7. Building Address: 520 Cantril Street
8. Owner Name and Address: Danny Lee and Loretta Mae Reese; 520 Cantril Street, Castle Rock, CO 80104

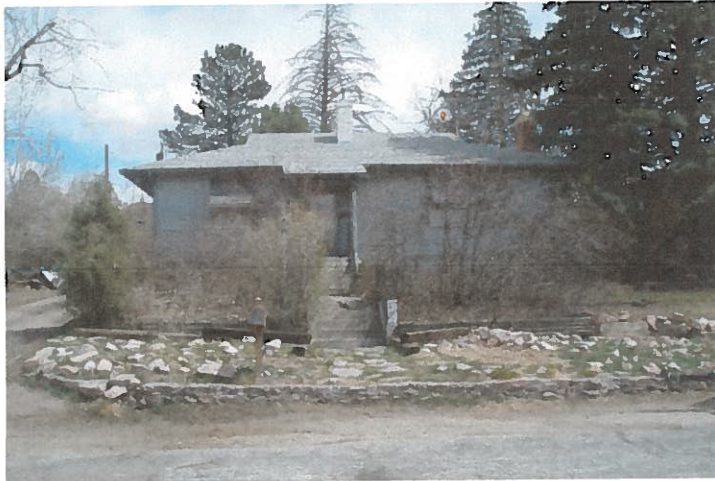
14. Building Plan: Rectangular Plan
15. Dimensions in Feet: 32 feet x 46 feet
16. Stories: One
17. Wall Material: Wood/Weatherboard/Horizontal Siding
18. Roof Configuration: Hipped Roof
19. Roof Material: Composition Roof
20. Special Features: Chimney Fence  
Porch
21. Architectural Description:

The house was a side gable cottage and through the years, hipped roof additions were added to the building on the north, south and west elevations. There was a shed roof addition added to the east elevation later. The building is clad with wood horizontal lapped siding, painted grey. The ends of the exposed gables are asbestos siding. The roof on the building is composition with exposed rafter tails. There are half round painted gutters and downspouts and 1/6 painted trim boards at the corners. There are three chimneys on the house. There is one on the west side of the roof ridge and one on the east side of the roof ridge. Both are brick covered with stucco. The third chimney is on the south end of the building and it is exposed stucco.

**West Façade:** The west elevation is the primary entrance into the building. The entrance door is offset to the north on this elevation. The stained wood door is 1970s vintage with three square glass panels. There is a glass storm door on the exterior. There is a shed roof over the entrance supported by simple Doric style columns. To the south of the door is a grouping of three wood windows with storm windows on the exterior and metal awnings. To the north of the door is a single window with an aluminum storm window and metal awning.
