COLORADO CULTURAL RESOURCE SURVEY
Architectural Inventory Form

1. Resource Number: 5DA2725
2. Temporary Resource Number: 785
3. County: Douglas
4. City: Castle Rock
5. Historic Name: None
6. Current Building Name: Eakins & Company P.C., Certified Accountants
7. Building Address: 407 Wilcox Street
8. Owner Name and Address: Paul and Nancy Eakins, 4345 Lake Gulch Road, Castle Rock, CO 80104

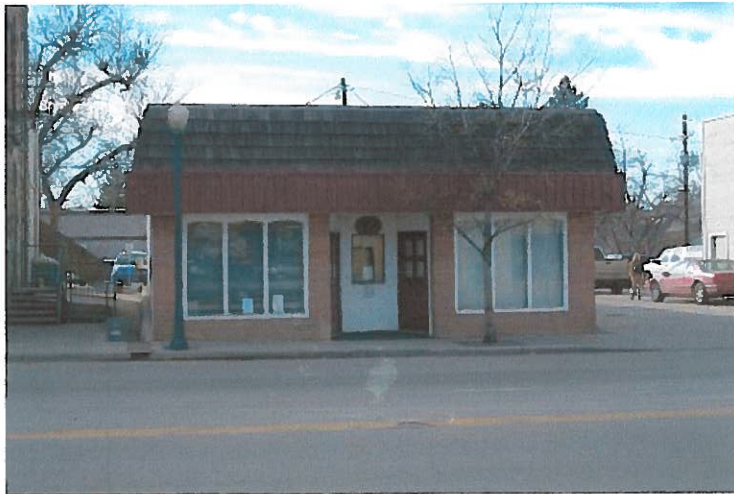
General: The building is primarily a concrete block building with a shed roof.

Front Façade: The elevation has a cedar shingle, shed roof above a boxed, rectangular pediment that spans the entire façade. The pediment is wood and extends beyond the face of the building approximately 12". It is clad in 1x painted wood that has been installed to create a paneled appearance. Below the pediment, the building is clad with narrow, decorative, blonde brick. The entrance to the building is recessed and centered on the façade with two doors at an angle to the elevation. It is believed that, historically, the entrance was recessed and centered on the elevation with angled sidelites. These sidelites are now the entrances to the building, and where the historic door was once located, is framed and stuccoed with a rectangular, plate glass window. There are three-lite, vertical, wood windows that flank the recessed entrances.

South Elevation: The concrete block is painted and has a metal capped, stepped parapet. There are no openings in this elevation.

West Elevation: This elevation is painted concrete block laid in a running bond pattern. There is a gutter and downspout at the roof edge. Historically, there was a window with a concrete sill on this elevation, but it has been removed and infilled with concrete block.

North Elevation: This elevation is painted concrete block laid in a running bond pattern with a metal capped, stepped parapet. Near the west end is a metal, drive-up window with a cedar shingle, shed roof that was utilized when this building was a bank.
