SELLARS GULCH DRAINAGEWAY MASTER PLAN EXECUTIVE SUMMARY

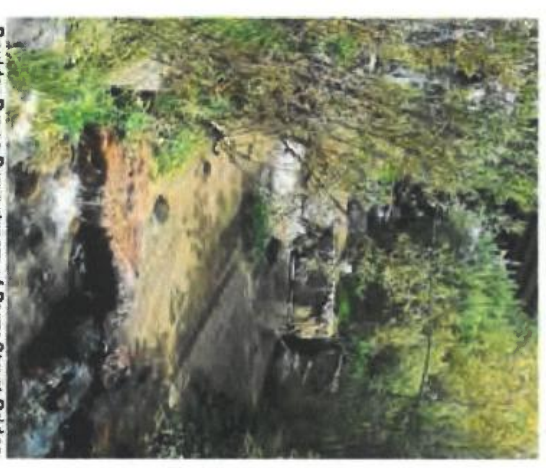
Boulder Drops Downstream of Perry Street Bridge
