# **COLORADO CULTURAL RESOURCE SURVEY**

**Architectural Inventory Form**

1. Resource Number: 5DA.2666

5. Historic Name: Castle Rock Fuel and Feed

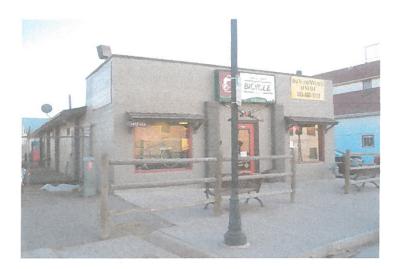
This is a twentieth century commercial building constructed of painted concrete block. There are cmu curved corner columns that flank the central entrance door and are spaced equally down both the east and west elevation. The north façade has a flat parapet with a central single lite door with plate glass windows flanking the door. Each plate glass window has a simple wood shingle clad awning supported by wood brackets.
